**REMOVAL PROGRAM  
PRELIMINARY ASSESSMENT/  
SITE INVESTIGATION REPORT  
FOR  
TURKEY BROOK SITE  
OAKVILLE, LITCHFIELD COUNTY, CONNECTICUT  
9 OCTOBER 2013 THROUGH 19 FEBRUARY 2014**

Weston Solutions, Inc.  
Region I  
Superfund Technical Assessment and Response Team III (START)  
3 Riverside Drive  
Andover, MA 01810

March 2014

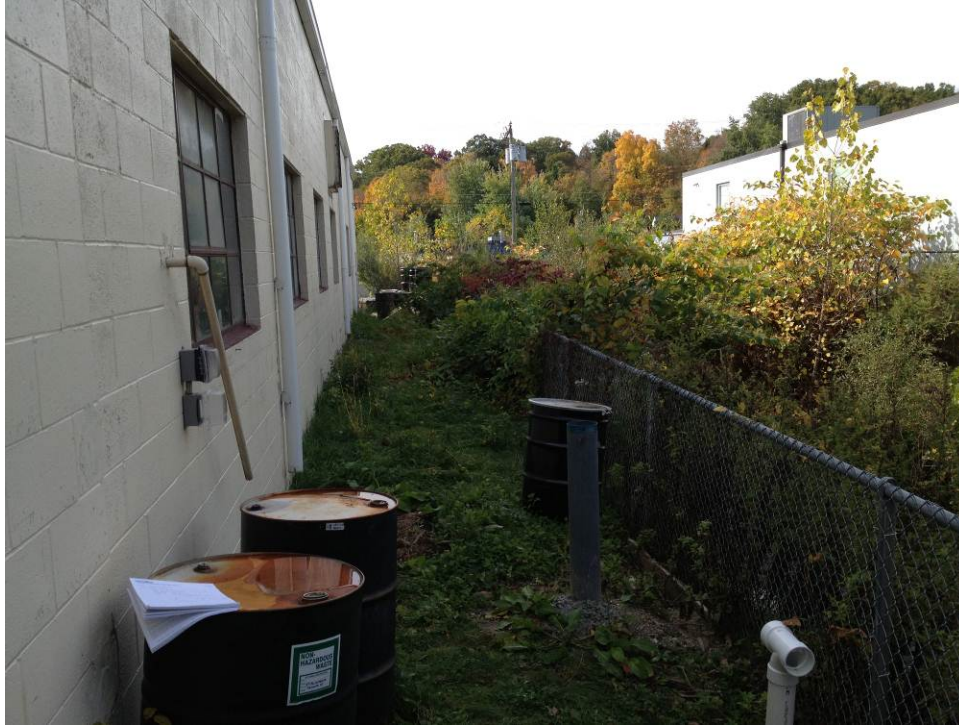
**SCENE:** View of west side of Quality Automatics, Inc. building, vent pipe, and staged 55-gallon drums. Photograph taken facing southwest.

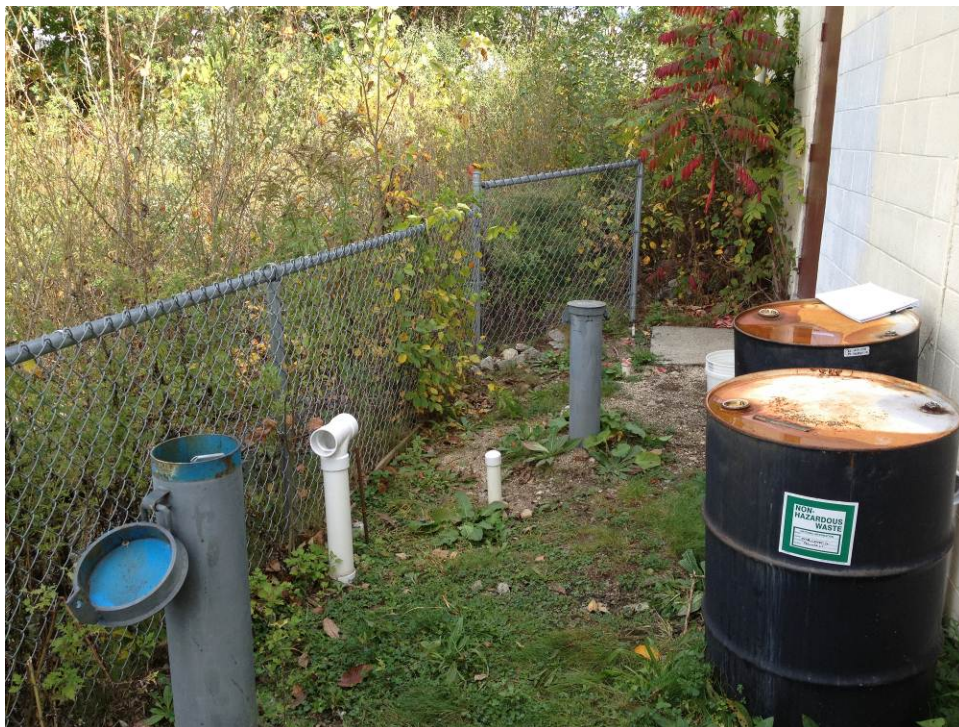
**SCENE:** View of monitoring wells, T-shaped pipe, and 55-gallon drums located on west side of Quality Automatics, Inc. building. Photograph taken facing northeast.

Mr. Mavris observed the following monitoring wells/piezometers outside the backdoor: two monitoring wells constructed of 4-inch-diameter polyvinyl chloride (PVC) with steel outside protective casings; two monitoring wells constructed of 2-inch-diameter PVC; and two piezometers/monitoring wells constructed of 0.5-inch-diameter PVC. Two T-shaped pipes, constructed of PVC, were also noted in this area (see Appendix C, Photo-Documentation Log). Since a water level meter and oil/water interface probe were not available, the depths of the monitoring wells and piezometers, depth to water, and oil thickness (if any) were not recorded.

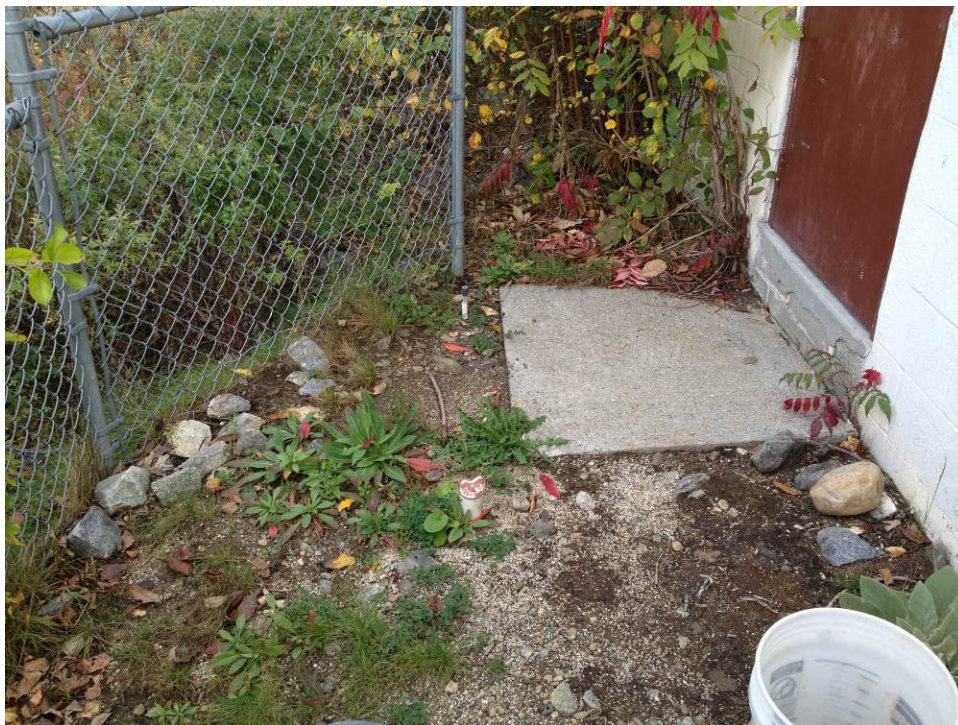
**SCENE:** View of piezometer and monitoring well located on west side of Quality Automatics, Inc. building. Photograph taken facing northeast.

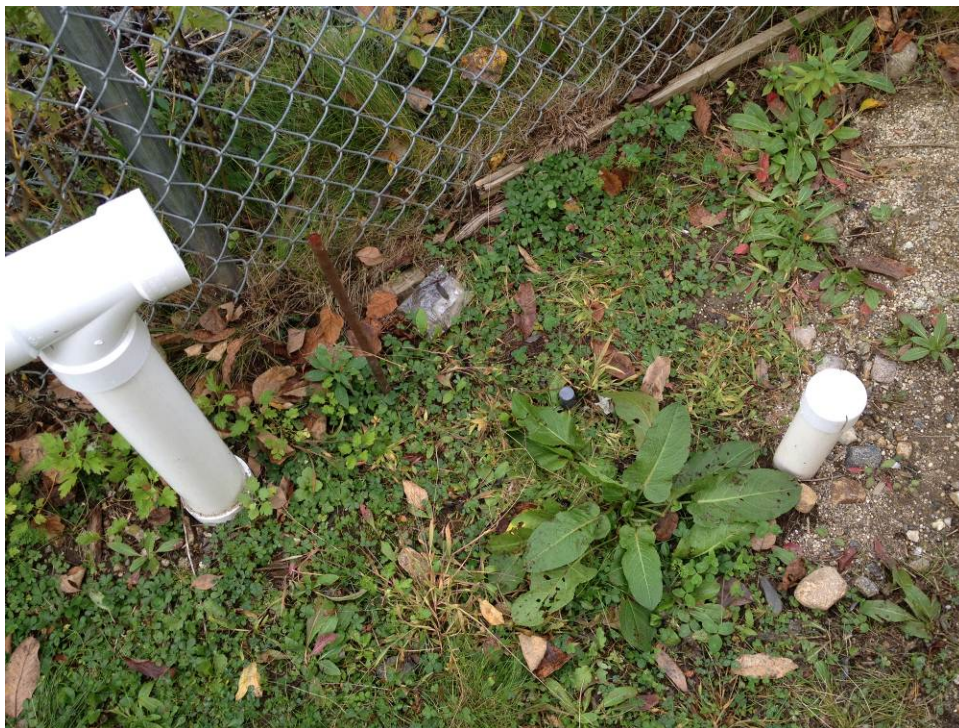
**SCENE:** View of T-shaped pipe and 2-inch monitoring well located on the ground surface along the northwestern side of the Quality Automatics, Inc. building. Photograph taken facing northwest.

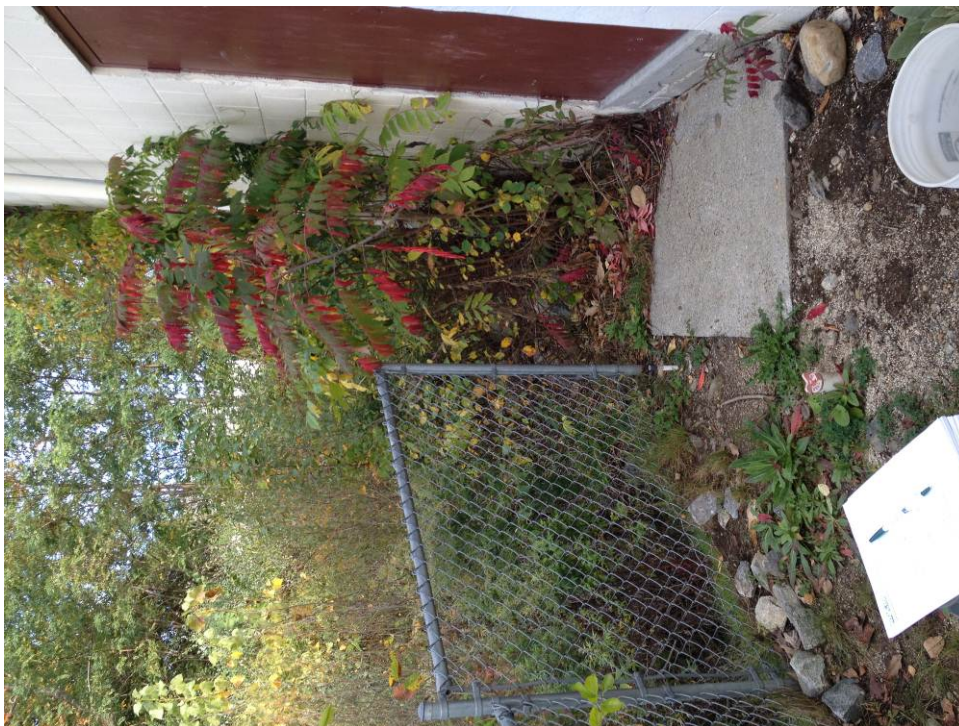
**SCENE:** View of 2-inch and 0.5-inch monitoring wells located left of concrete pad and directly in front of back door to the Quality Automatics, Inc. building. Photograph taken facing northeast.

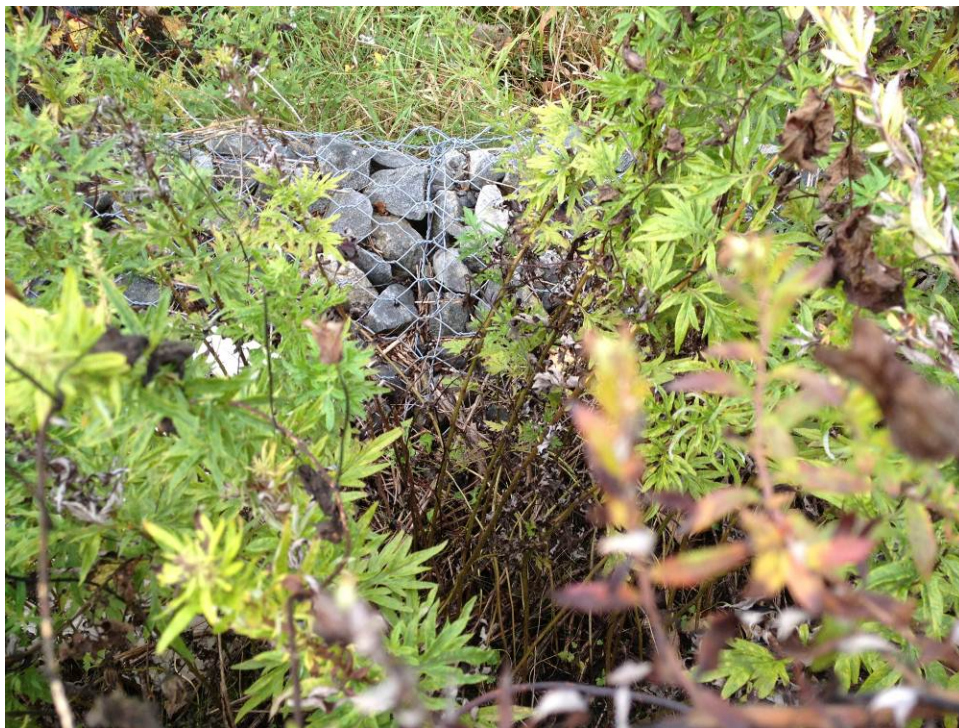
**SCENE:** View of gabions along east bank of Turkey Brook adjacent to Quality Automatics, Inc. building. Photograph taken facing northwest.

The grassy area between the chain-link fence and west side of the building along Turkey Brook was approximately 7 feet wide. A grassy area, approximately 2.5 feet wide, extended beyond the fence. The banks of Turkey Brook were stabilized by gabions, approximately 2 feet wide. Three 55-gallon drums containing used absorbent oil booms were located against the building wall near the monitoring wells. One oil absorbent boom was observed in Turkey Brook near the monitoring wells. No oil or sheen was noted upstream or downstream of this boom. The

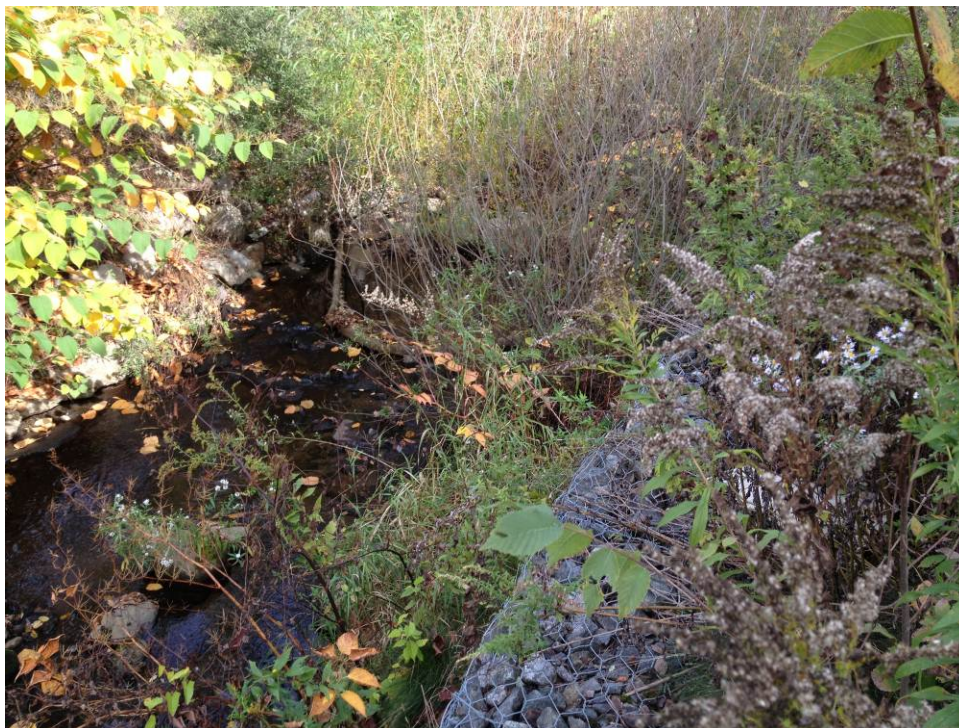
**SCENE:** View of oil absorbent boom located in Turkey Brook and upstream of monitoring wells on the Quality Automatics, Inc. property. Photograph taken facing northeast.

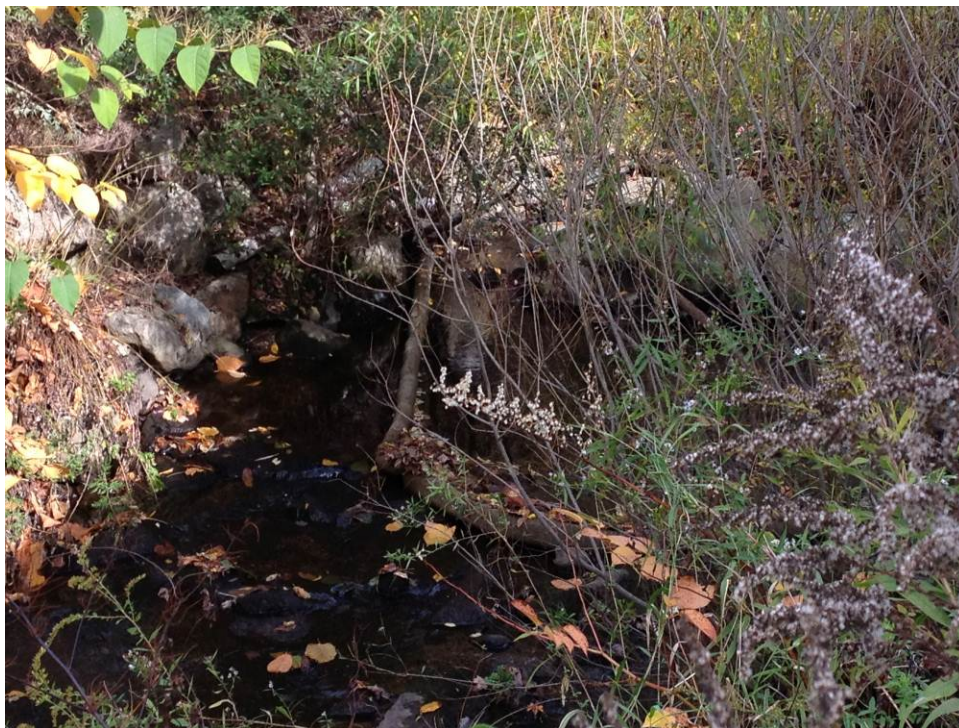
**SCENE:** View of oil absorbent boom located in Turkey Brook and upstream of monitoring wells on the Quality Automatics, Inc. property. Photograph taken facing northeast.

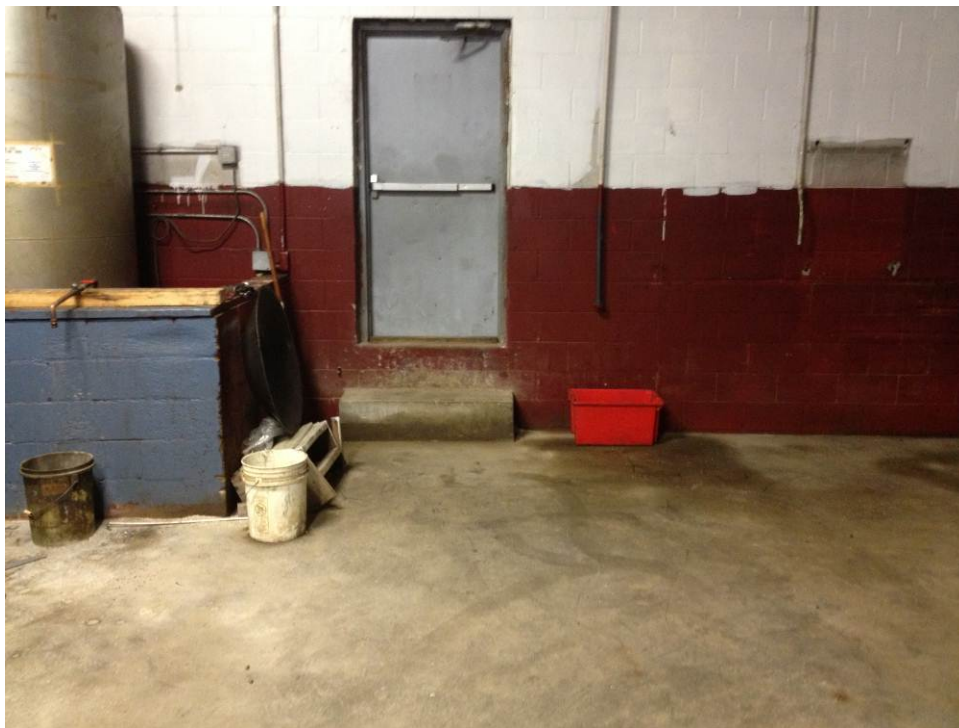
**SCENE:** View of back door of Quality Automatics, Inc. building leading outside to location of monitoring wells, and a solvent tank. Photograph taken facing northwest.

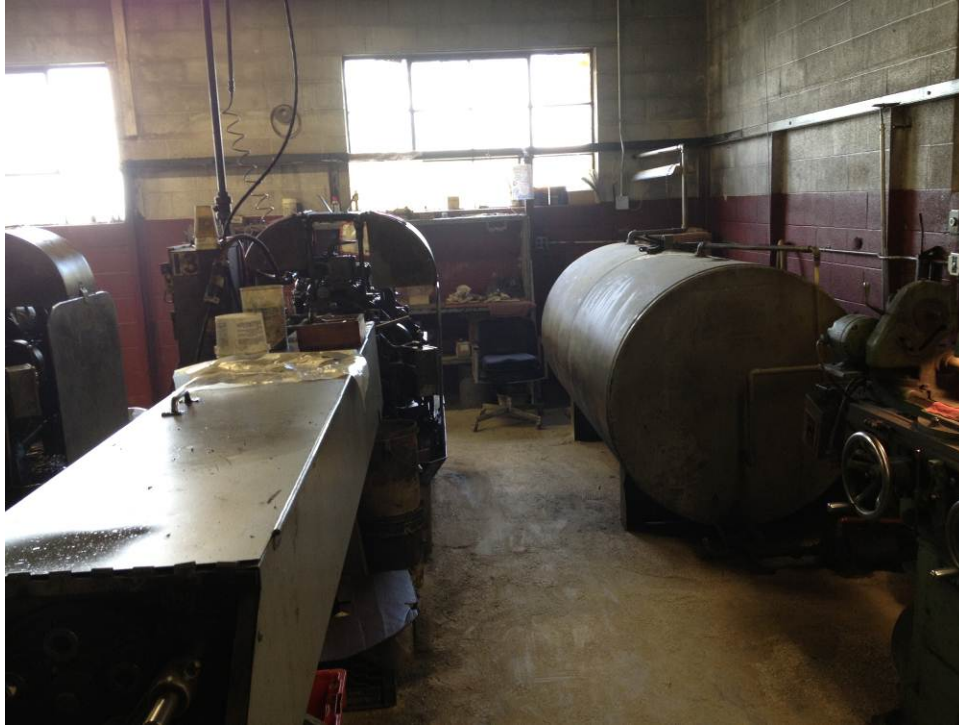
**SCENE:** View of large aboveground storage tank located in northwest section of the machine shop in the Quality Automatics, Inc. building. Photograph taken facing northwest.

<b>Parameter</b>	<b>Quantities/Extent</b>
( ) <b>Cylinders:</b>	
( ) <b>Drums:</b>	
( ) <b>Lagoons:</b>	
(✓) <b>Tanks:</b>	(✓) <b>Above:</b> One large (approximately 500-gallon) aboveground storage tank (AST) and a smaller (275-gallon) AST were observed in the northwest and southwest corners of the machine shop inside the QAI Building. An approximate 1,000-gallon solvent tank (empty) was observed in the southwest corner of the smaller room attached to the machine shop area.
( ) <b>Below:</b>	
( ) <b>Asbestos:</b>

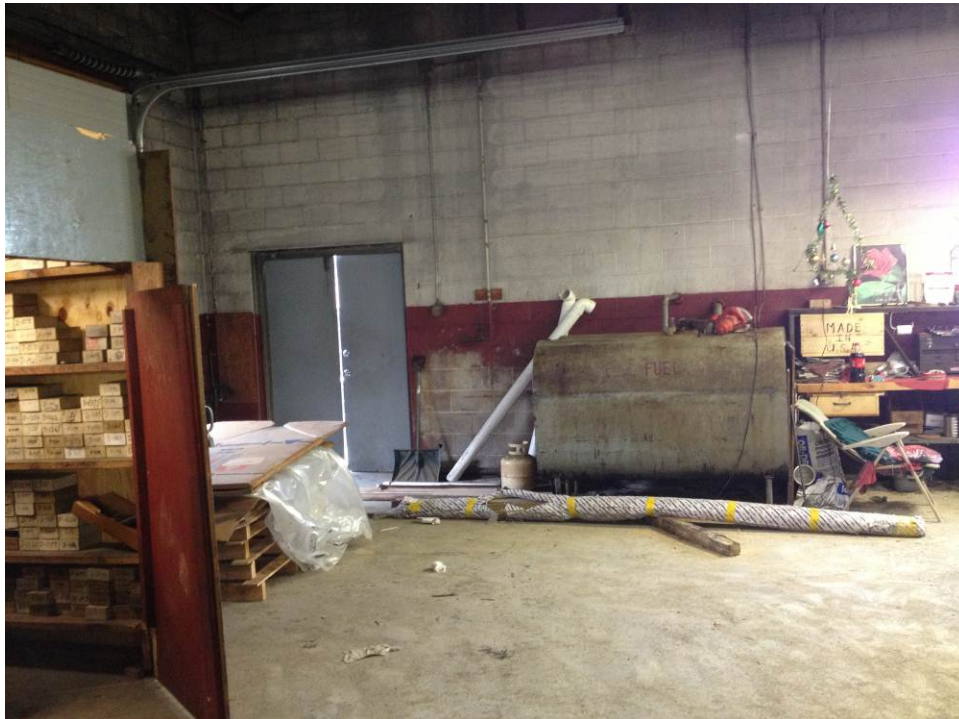
**SCENE:** View of 275-gallon aboveground storage tank located in southwest section of the machine shop in the Quality Automatics, Inc. building. Photograph taken facing southeast.

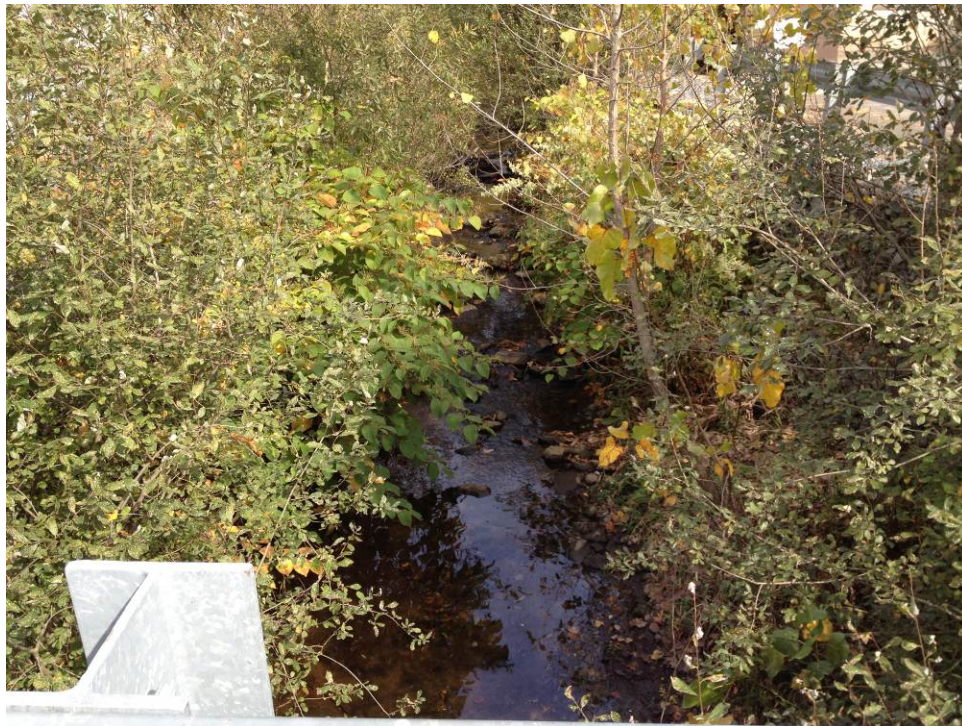
**SCENE:** Upstream view of Turkey Brook from McLellan Drive. Photograph taken facing northeast.

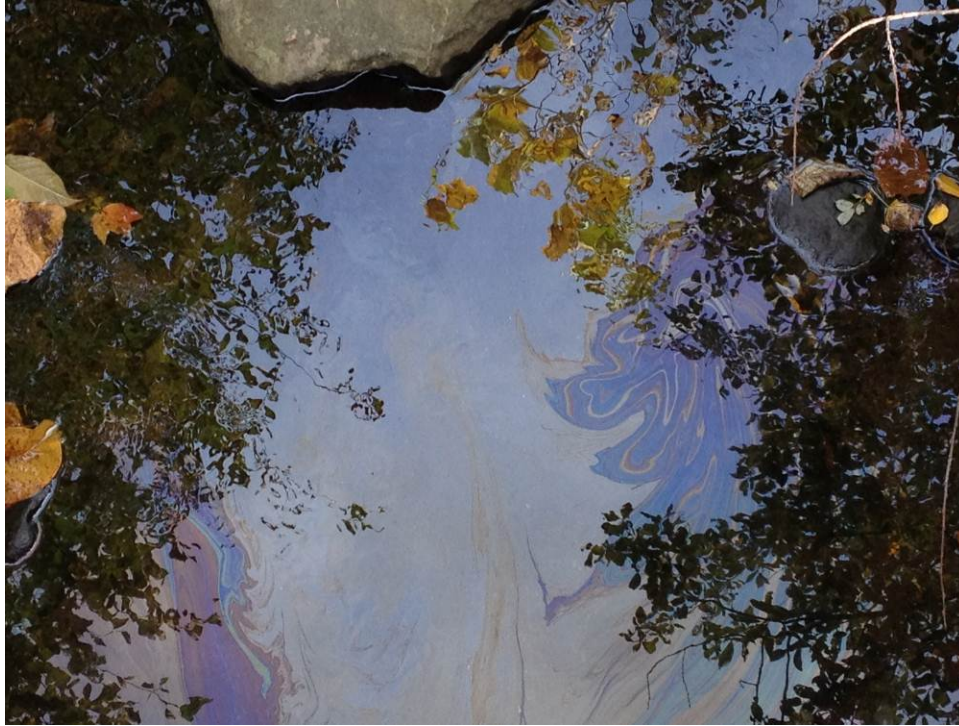
**SCENE:** View of sheen on Turkey Brook upstream of oil absorbent boom and north of McLellan Drive. Photograph taken facing northeast.

Mr. Mavris proceeded to the small bridge over Turkey Brook (north side of McLellan Road) and observed the absorbent oil boom located just north of the bridge. A prominent sheen was noted in the water upgradient of the oil absorbent boom (see Appendix C, Photo-Documentation Log). The elevation difference between the ground surface near the paved parking lot of the on-site building and the water in Turkey Brook was approximately 10 feet. Eighteen 55-gallon drums containing used oil absorbent booms were located against the chain-link fence near the southwestern corner of the on-site building. A fill and vent pipe leading into the 275-gallon AST was noted, and a second vent pipe leading into the large AST was noted protruding from the building wall in the vicinity of the monitoring wells. Four roof drain pipes were located along the western side of the on-site building. Other site features noted include: another monitoring well on the pavement in front of the garage door in front of the on-site building, several catchbasins in front of the on-site building on both sides of the road, catchbasins directly over Turkey Brook on both sides of the road, and Call Before U Dig (CBUD) utility markings on the property and road.

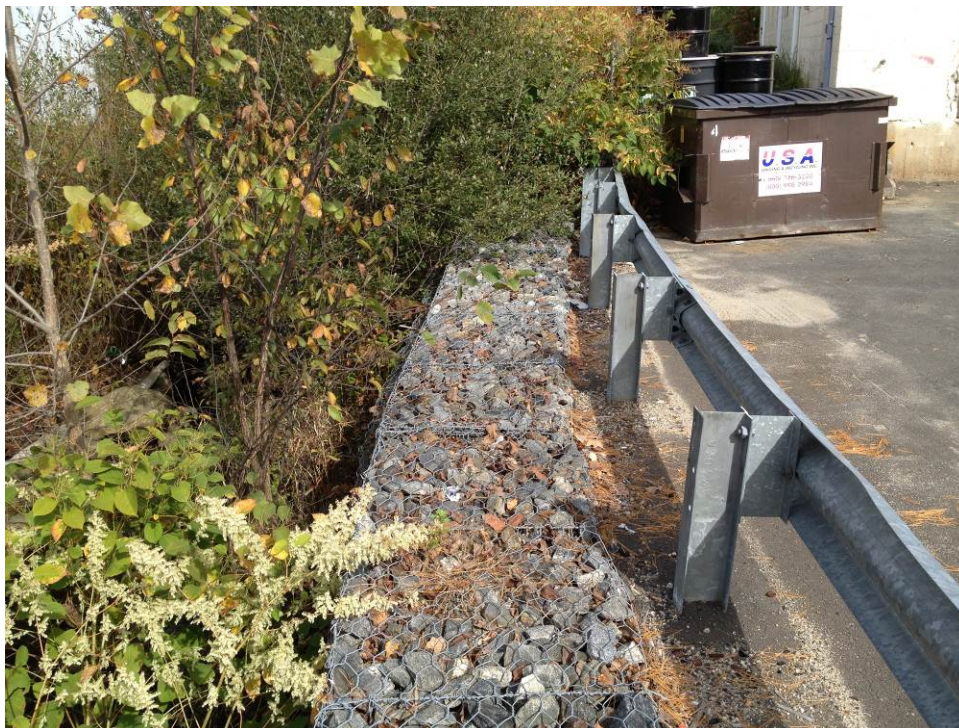
**SCENE:** View of gabion reinforcing eastern bank of Turkey Brook adjacent to the Quality Automatics, Inc. building. Photograph taken facing northeast.

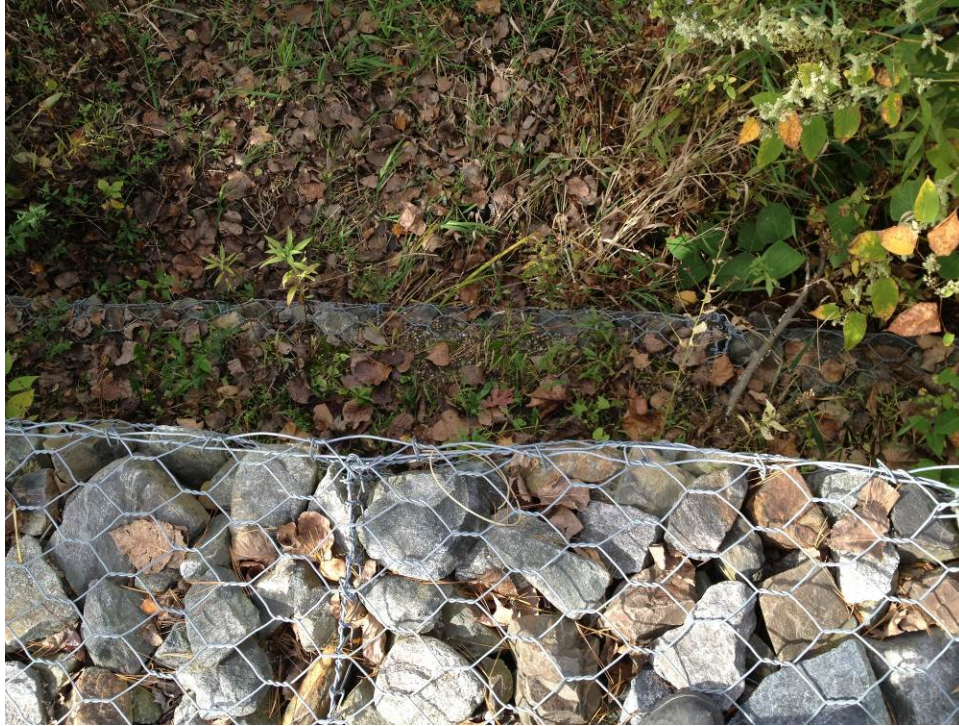
**SCENE:** View of stacked gabions along eastern bank of Turkey Brook adjacent to the Quality Automatics, Inc. building. Photograph taken facing northwest.

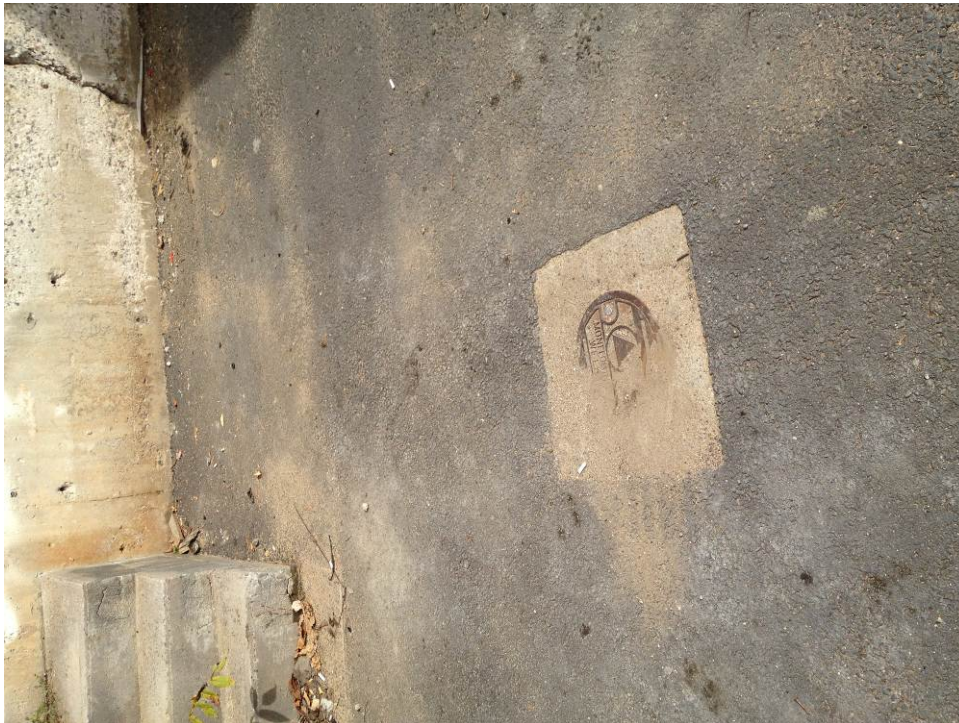
**SCENE:** View of monitoring (number unknown) located in front of bay door of Quality Automatics, Inc. building. Photograph taken facing northeast.

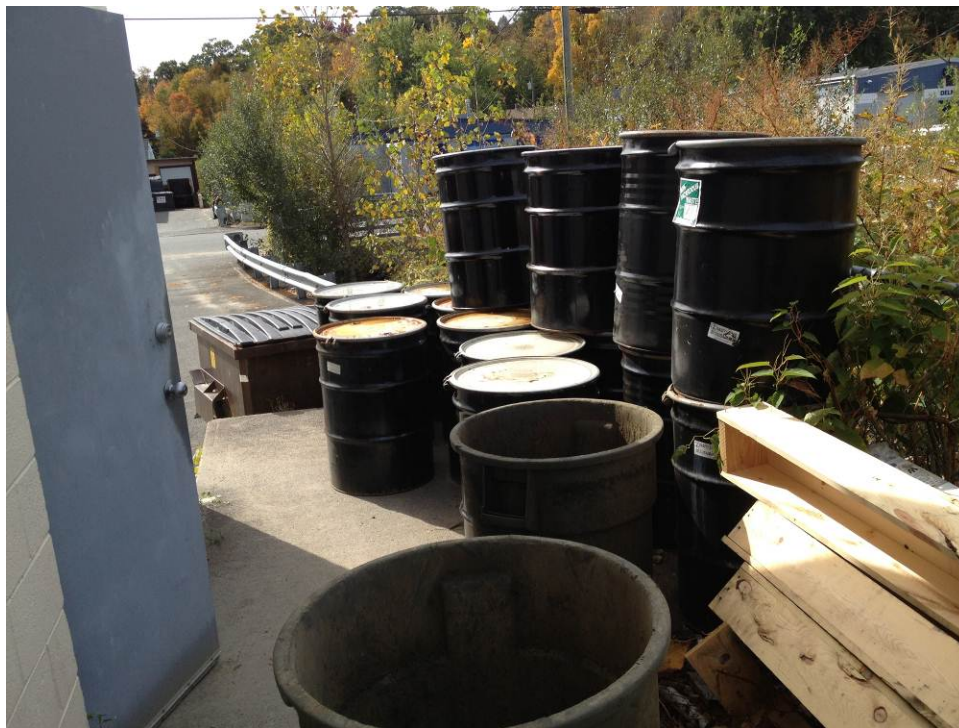
**SCENE:** View of 18 55-gallon drums containing used oil absorbent booms, located at southwestern corner of Quality Automatics, Inc. building. Photograph taken facing southwest.

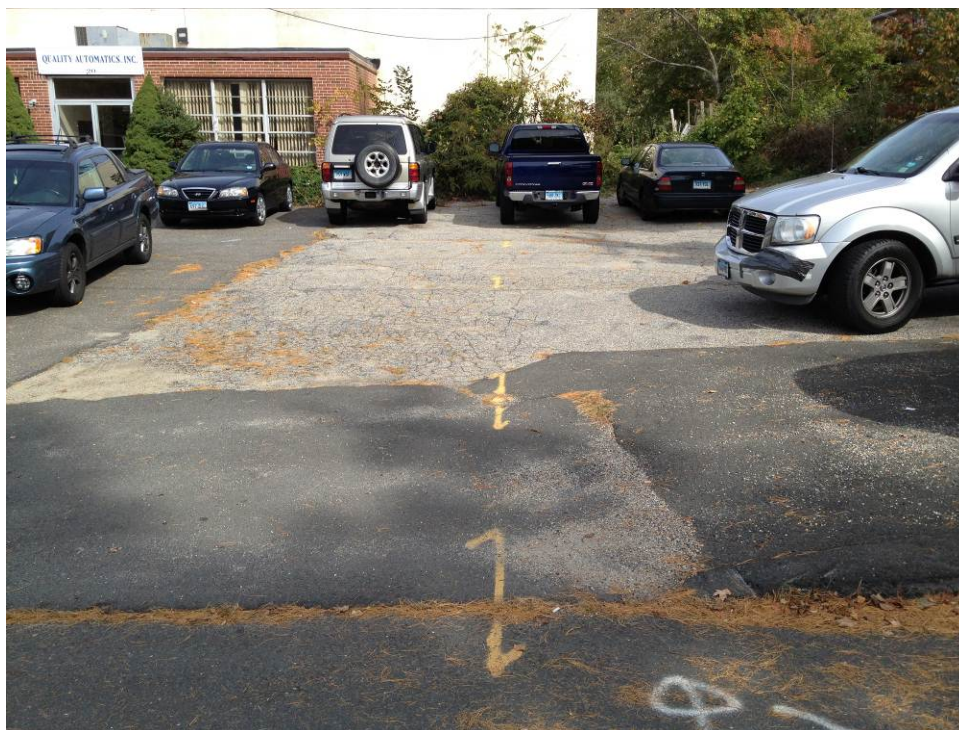
**SCENE:** View of gas line markings in parking lot of Quality Automatics, Inc. Photograph taken facing northeast.

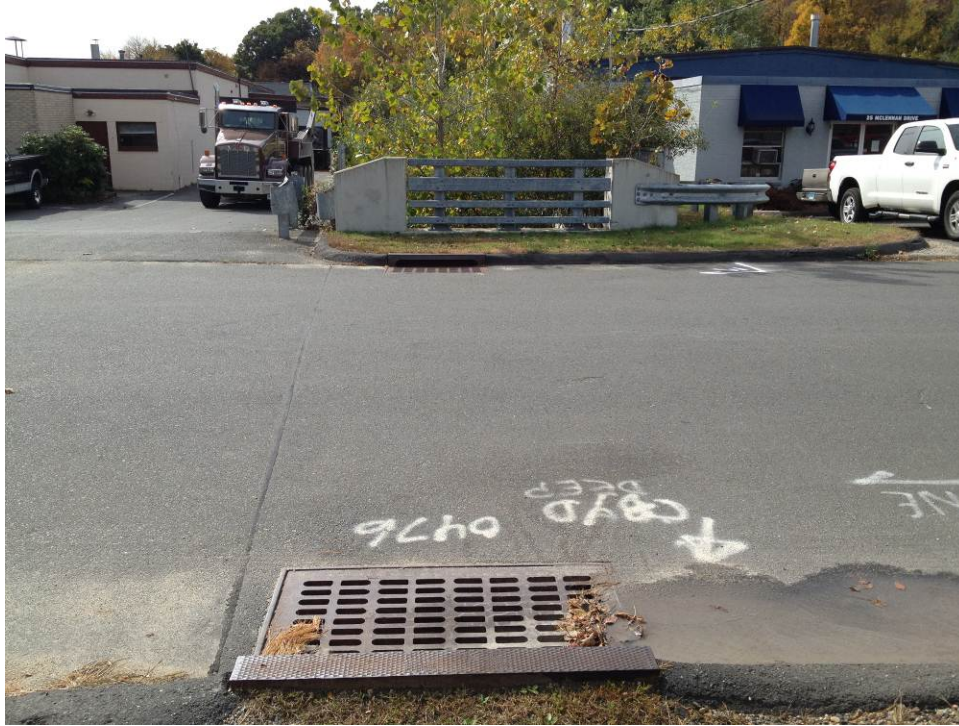
**SCENE:** View of two catchbasins located directly above Turkey Brook along McLellan Drive. Photograph taken facing northeast.

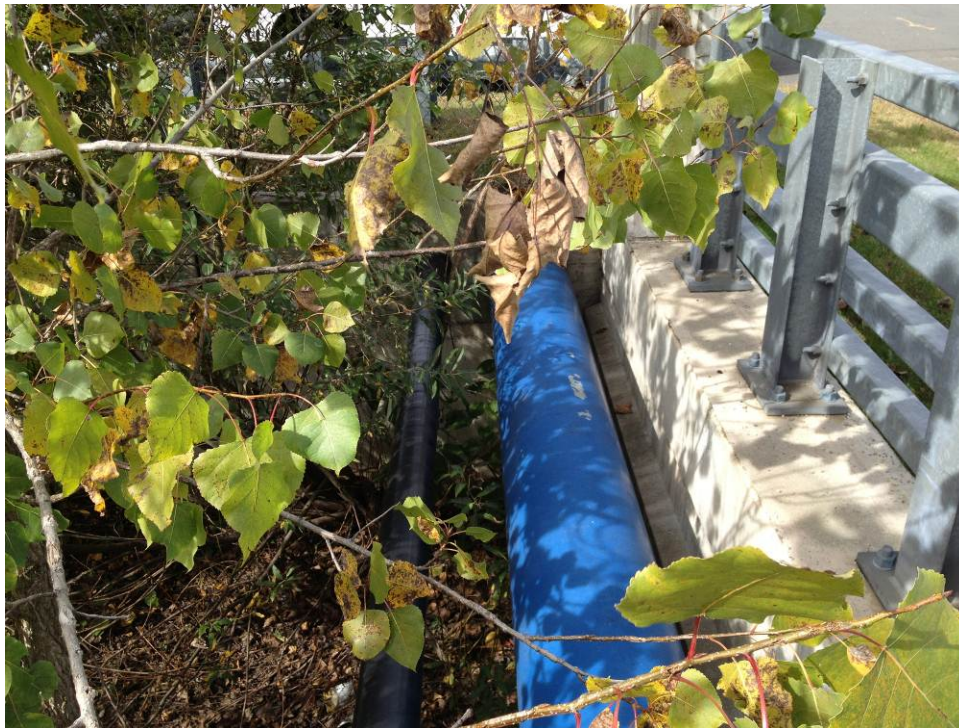
**SCENE:** View of blue and black pipes crossing Turkey Brook along southern side of McLellan Drive. Photograph taken facing northwest.

A blue pipe and a black pipe, oriented parallel to McLellan Road and crossing Turkey Brook, were observed from the south side of McLellan Road (see Appendix C, Photo-Documentation Log). As the water in Turkey Brook flowed south past these pipes, it flowed against a concrete wall along the property line of the QAI office building located at 15 McLellan Road.

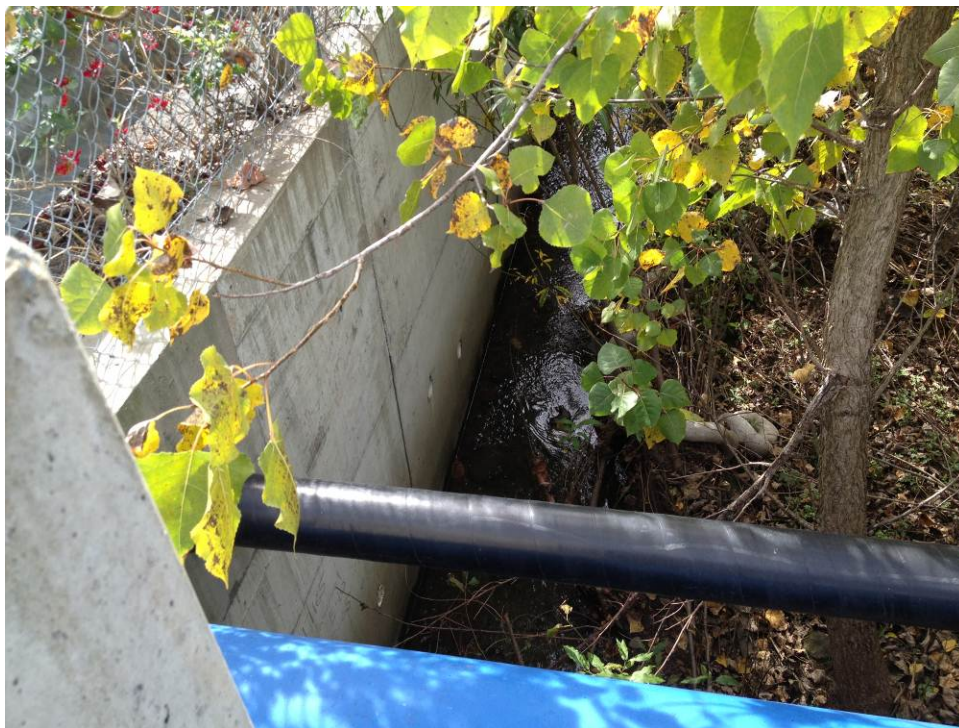
**SCENE:** View of blue and black pipes crossing Turkey Brook and surface water flowing along concrete wall adjacent to the Quality Automatics, Inc. facility located on south side of McLellan Drive. Photograph taken facing southwest.

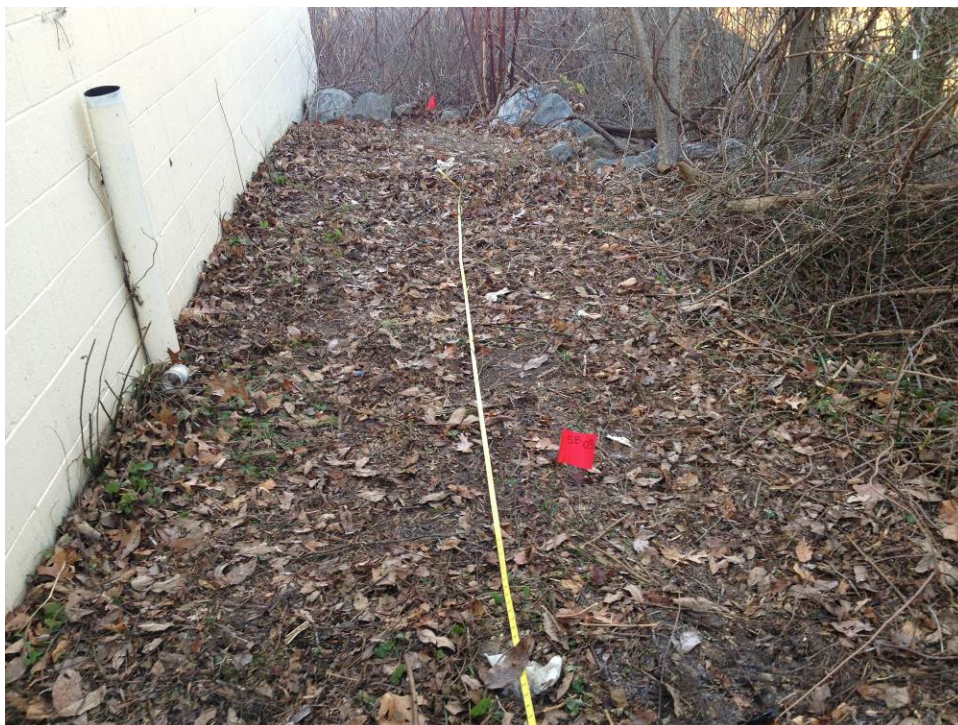
**SCENE:** View of soil boring locations SB-03 and SB-04 located on the northern side of the Quality Automatics, Inc. building (20 McClellan Drive). Photograph taken facing west.

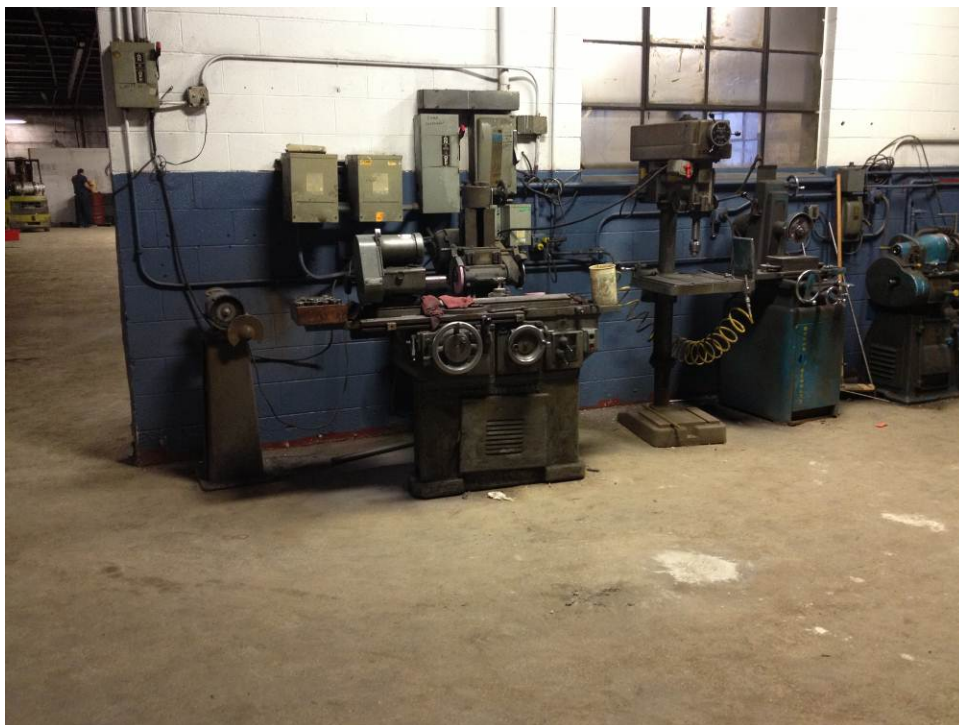
**SCENE:** View of soil boring location SBC-03 located inside of the Quality Automatics, Inc. building. Photograph taken facing south.

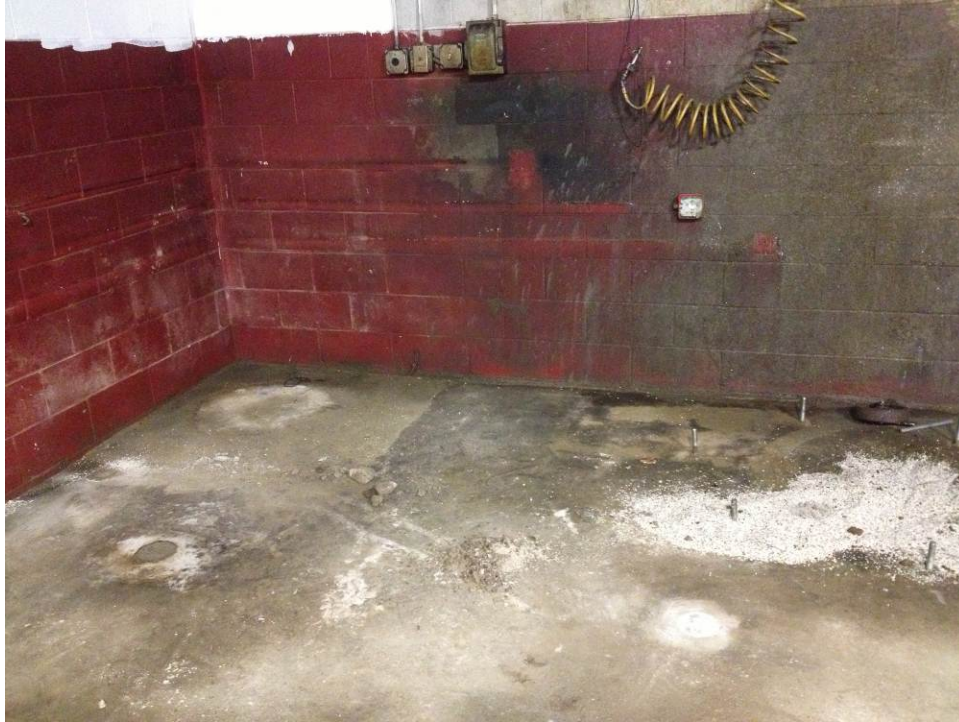
**SCENE:** View of soil boring locations SBC-07 and SBC-08, located inside of the Quality Automatics, Inc. building.  
Photograph taken facing north.

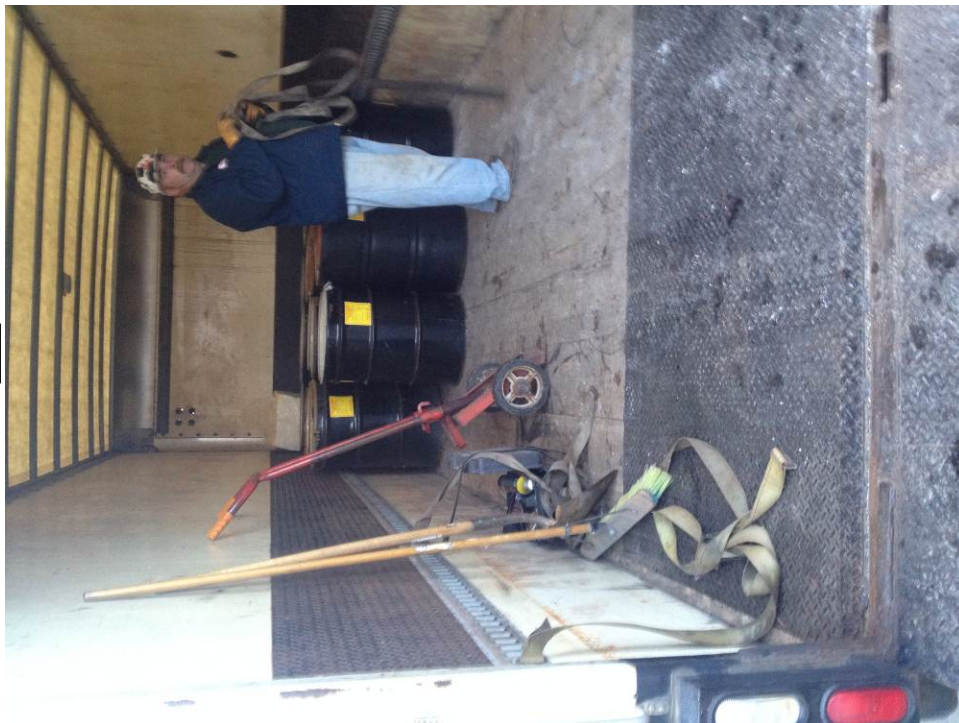
**SCENE:** View of the loaded drums containing petroleum waste being secured for transportation to the disposal facility.

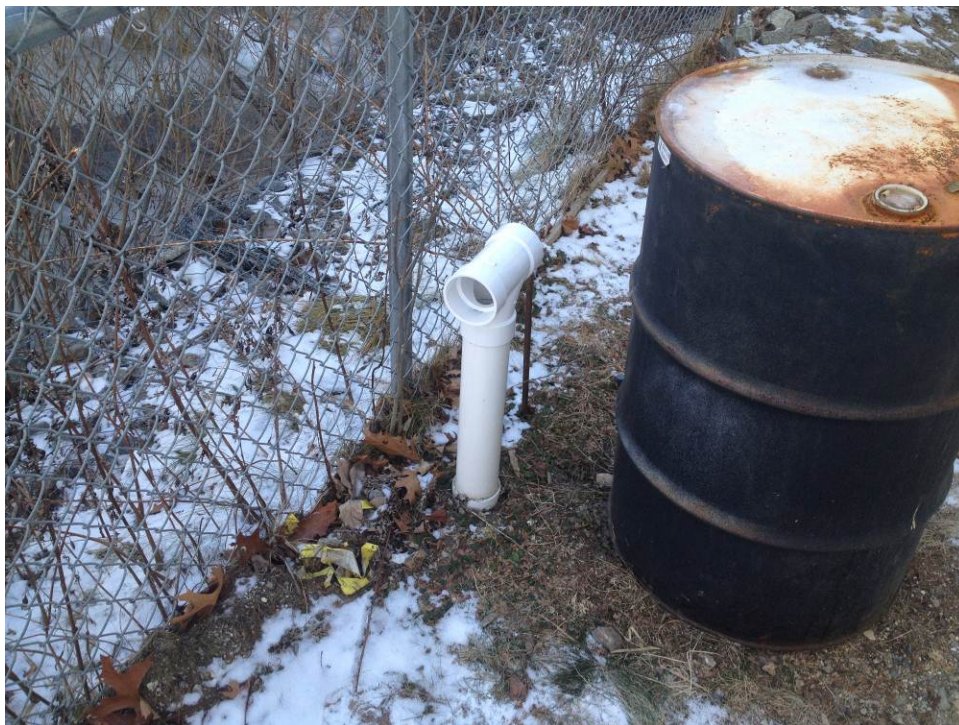
**SCENE:** View of a T-shaped polyvinyl chloride (PVC) pipe located on the western side of the Quality Automatics, Inc. building.

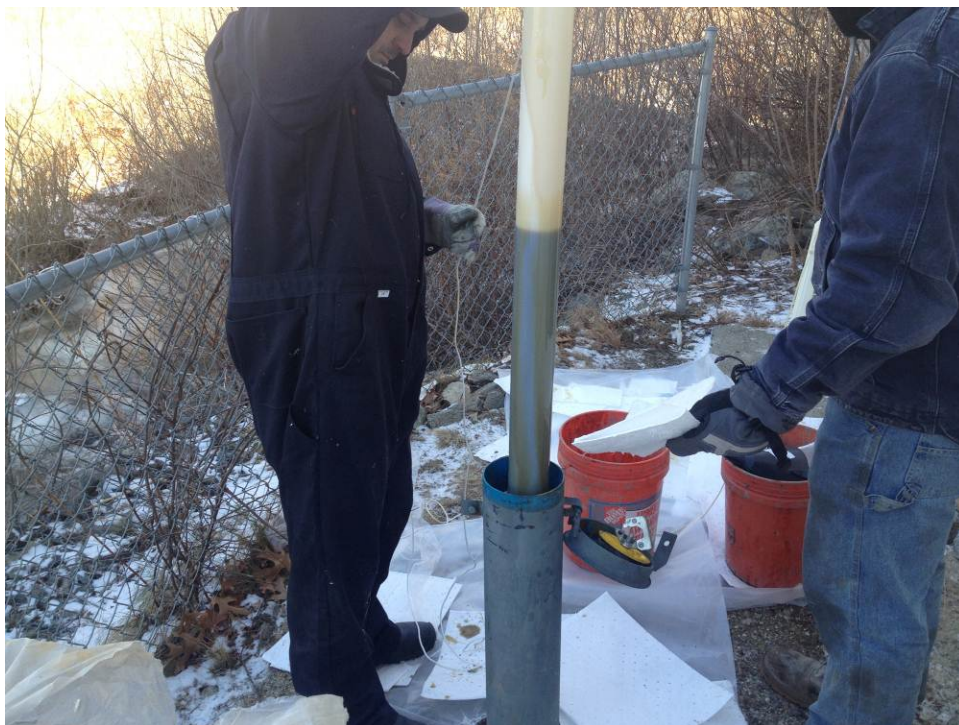
**SCENE:** View of product and water being bailed out of the on-site monitoring wells to observe the recharge rate of the wells.

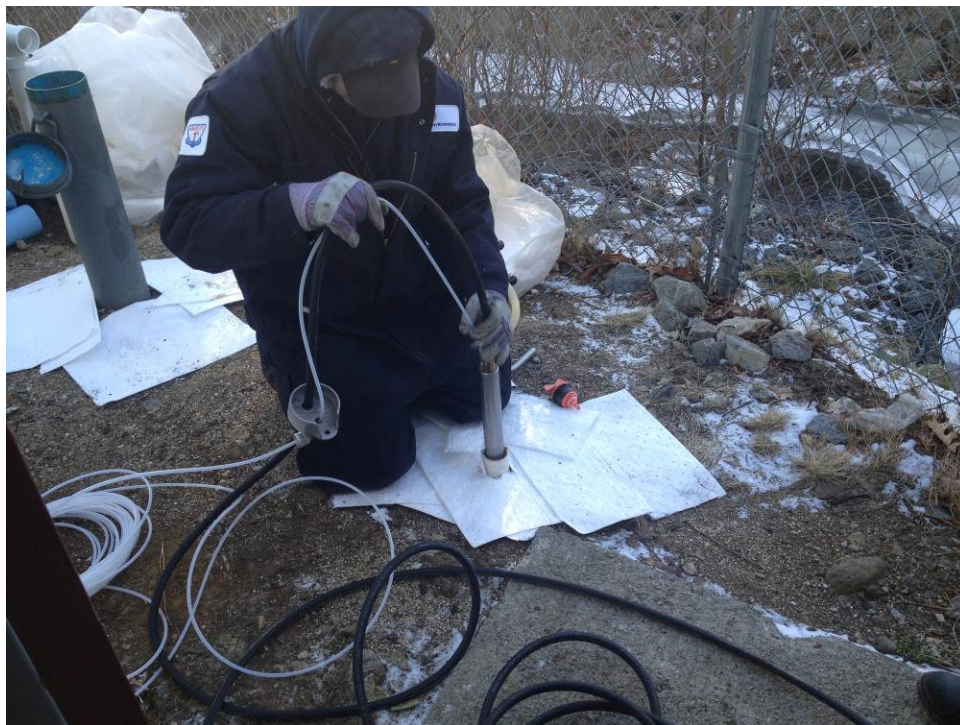
**SCENE:** View of the GeoTech SpOILer Controless Recovery Pump being installed into monitoring well MW-6.

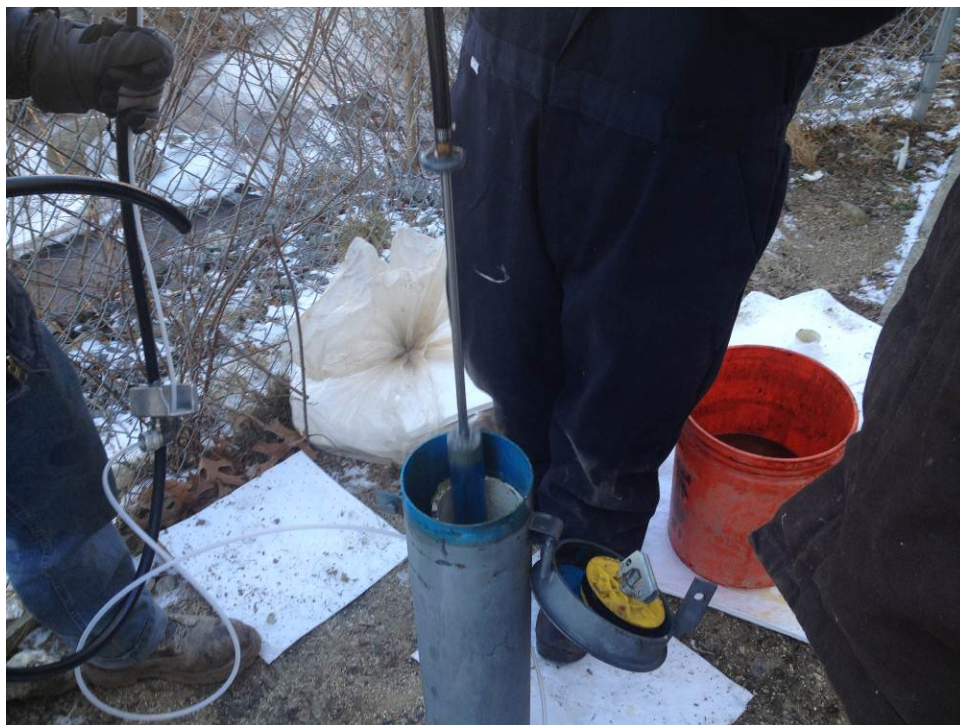
**SCENE:** View of the GeoTech SpOILer Controless Recovery Pump being installed into monitoring well MW-05.
